An analysis regarding train derailments caused by cracked wheelsets

Eugen Ghita¹

¹Politehnica University, Faculty of Mechanical Engineering, Timisoara, Romania

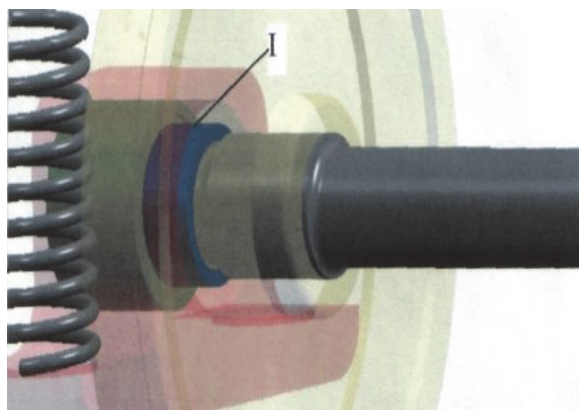
Based on the analysis carried out at the accident site by the research commission [2], it was established that "The breakage of the axle shaft, in the transition (connection) area between the axle shaft and the shutter area, occurred in the distance between Hm Cotești and CFR Guguști Station ..."

Figure 1: Cracking zone

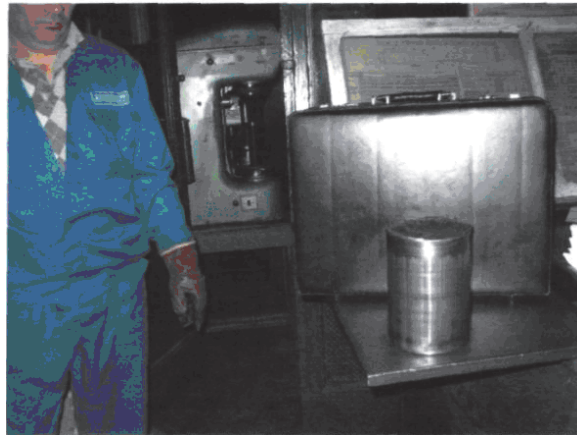
Photos of the broken spindle after deformation (Fig. 2) confirm the break in the connection area in the obturator, at a distance of 5-10 mm from the obturator diameter. So, the break did not occur in an area where the stress level would have been maximum. According to Navier's formula and the bending moment diagrams, the maximum stress and bending moment would be located in the middle of the axle. The axle was a driving axle that taken over, therefore, and a torsional moment being subjected to a stress composed of bending and torsion which, according to resistance theories, are equated to a single equivalent moment.

Figure 2: Spindle broken in the Gugești accident dismantled at SIDEX Galati

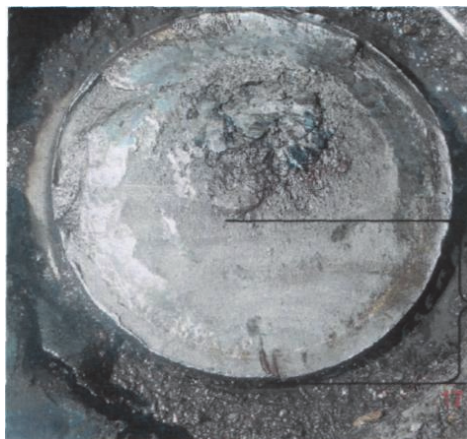
The macroscopic appearance of the fracture surface (Fig. 3) indicates a fatigue fracture, starting from a previous defect, which may be a transverse crack. The fatigue fracture zone covers 30-40 % of the total fracture surface. The research report from confirms that "The surface of the fracture section presented the specific aspect of fatigue fracture generated by transverse cracks".

Figure 3: The macroscopic aspect of the rupture section at Gugești

According to the instructions for in-service ultrasonic control of mounted axles - AFER (ROMANIAN Railway Authority), [2], it was found "the presence in the breaking section of two radial cracks in the transverse direction of 10 and 15 mm respectively, whose primers (of semi-elliptical shape) extend over an area of 30% of the initial cross-section." Before leaving the grease box, the spindle continued to remain solid with the sealing ring on which it was pressed, deforming in the connection area. " From the findings, it emerged that the breaking of the axle shaft, in the transition (connection) area between the axle shaft and the shutter area, occurred as a result of exceeding the fatigue resistance limit of the material due to a manufacturing defect. This manufacturing defect was not detected during the controls performed by the manufacturer (respectively by SC SMR SA Balș) nor during operation during the ultrasonic control performed at the CFR Coșlariu station...", [2].

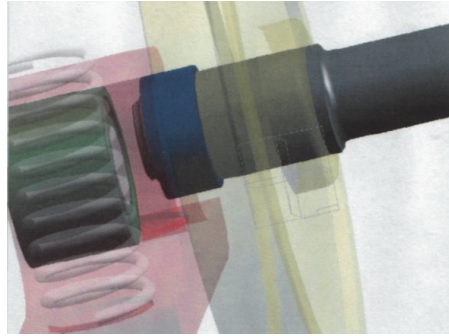
The sealing ring continued to rest on the bearing in the grease box housing, being pushed towards the wheel hub (Fig. 4).

Figure 4: Moving the sealing ring towards the wheel hub and rubbing it on the upper area of the grease box bearing

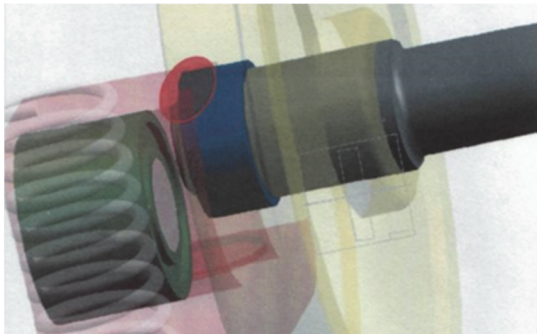
Pressing the grease box onto the seal ring with part of the weight of the carriage transmitted by the springs (less than 1/8 of the weight, because the grease box has moved down with the difference between the outer and inner radius of the bearings and consequently the springs of this box are less loaded) led, as a result of friction, to the heating of the contact area. Consequently, the grease box continued to descend through the deformation of the contact area, which resulted in the axle end being pressed into the box bearing (Fig. 5) until a channel was formed that allowed the box to fall (Fig. 6).

Figure 5: Hot deformation zone of housing, sealing ring and shaft end

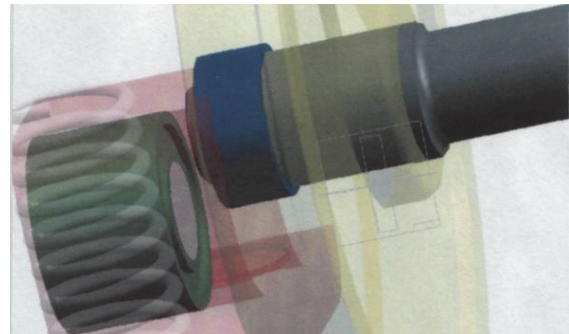
Figure 6: Detaching the grease box from the end of the axle

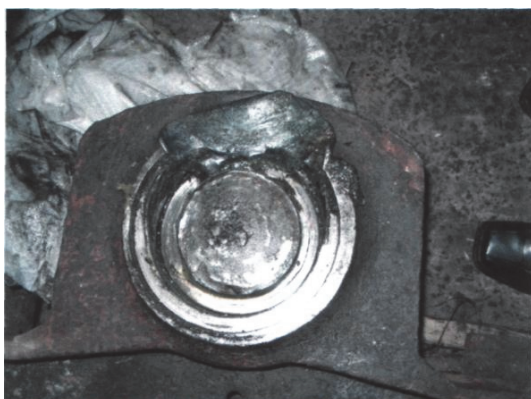
This failure mode was confirmed by the appearance of the grease box after deformation (Fig. 7). Deformation is confirmed by pressing the box vertically from top to bottom on the end of the axle. Simultaneously, the deformation and breakage of the sealing ring occurred, as well as the deformation of the end of the axle (Fig. 8):

Figure 7: Aspect of the deformed area of the grease box

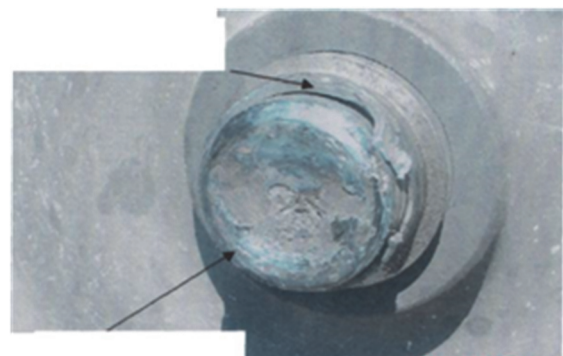
Figure 8: Aspect of the deformed area of the broken axle

This phenomenon was also highlighted in the research report in which it is specified that "Following the friction of the broken spindle pin in the upper edge of the axle box casing, major deformations occurred in the parts in contact, which allowed it to come out of the axle box and rolling friction on the inside face of the bogie frame."

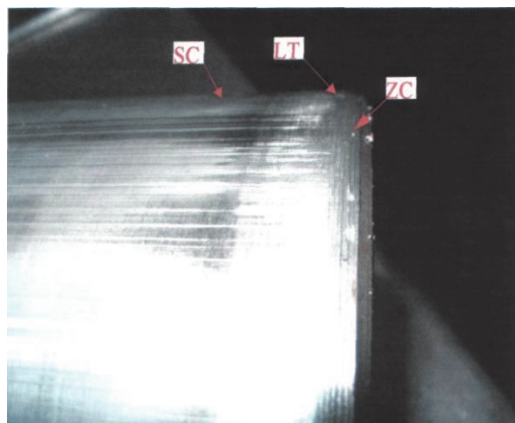
1. The end of the axle spindles has a clearance (5 mm x 6°), which is not found in the execution drawing and can be visualized in Figure 9. This clearance (above which the 2 x 45° clearance was also executed) is found in the design of type A I axles, but also in the design of OR 1 axles.

Figure 9: Tapered zone (ZC) on the end of the broken spindle

The existence of the conical surface with an inclination of 6° represents a deviation from the execution drawing, but it is not invoked as the cause of the spindle breaking, but as evidence of obtaining this axis by processing (cutting the ends) from an old one that had, according to the execution drawing, conical surface. The fact that this conical area has a variable width, but possibly highlighted in the expertise) is evidence of the processing at different grips of SC and ZC. Since ZC was machined by snapping to centering holes in the original axle, it follows that SC was machined by snapping to centering holes machined after cutting the ends. Considering the extremely small tolerances of the spindle on the initial axis (between $+0.037$ and $+0.059$ mm), any dimensional processing in this area involves increasing the diameter by previously adding a layer of material. Visual analysis allows, in the case of a broken axle, to highlight some circular marks on the surface of the spindle. It is specified that this cutting of the ends has the effect of removing all the markings that allow the identification of the modified axle. Whereas in the points of view of the C.F.R. no reference is made to the marking transfer operation, which is not included in the technological flow of the S.M.R. Balş, this operation cannot be considered as being included in a homologated technology and allows the loss of the identities of the modified axle.

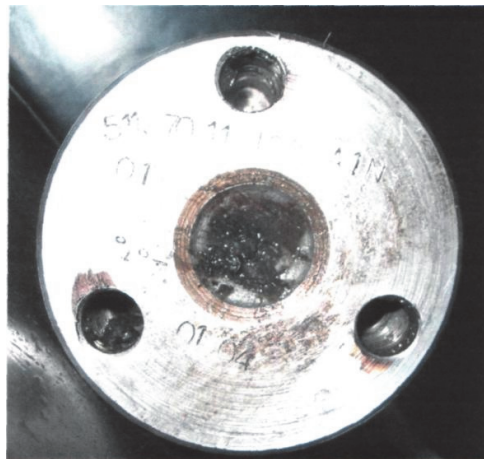
The analysis of the front surface of the broken spindle (Fig. 10) highlighted the fact that several areas can be distinguished on the front surface of the spindle which, by the color of the oxide, prove that they have undergone heating. After this heating the front surface was machined, but with insufficient machining allowance to remove stains from the knife exit area of the threaded holes. at the same time, the conical clearance to protect the centering hole remained unprocessed.

Figure: 10. Traces of heating on the front surface of the broken spindle

The uniform heating of the end of the axle to 255°C , before the finishing turning of the front surface, cannot be explained by any of the technological operations in the technological flow developed by S.M.R. Balş. This heating can only be explained by the need to carry out a heat treatment (low rebound, stress relief or preheating) applied to the axle. The application of a heat treatment (even at a temperature of 250°C) is not justified in the final phase of mechanical processing of the axle. Any such treatment should have been applied to the forged blank or roughened axle. The only plausible explanation is that the analyzed axle did not go through these stages (forged semi-finished or roughened axle), it comes from an old, refurbished axle. An old axle does not require subcritical heating, unless the refurbishment operation was required welding operations, which require preheating or stress relief. The application of this operation is to be confirmed by the analysis carried out further. The macroscopic analysis and the analysis with penetrating liquids confirmed the existence of some pores in all connection radii (Fig. 11 and 12).

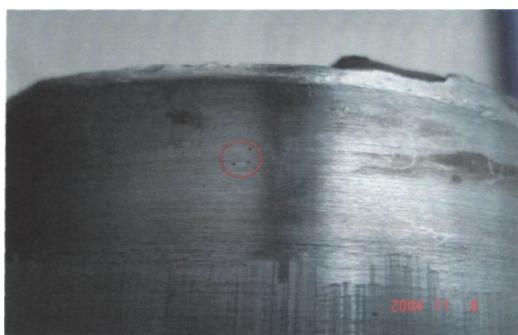
Figure 11: Pores on the surface of the broken spindle

It is found that the pores are located exclusively in the connecting radii. In addition, the pores have a circular section, which is not characteristic for a forged material where the possible porosities from casting are flattened or even closed. The circular pores indicate the existence of a metallurgical operation, which consists of local melting on the entire circumference of the axle in all connection areas.

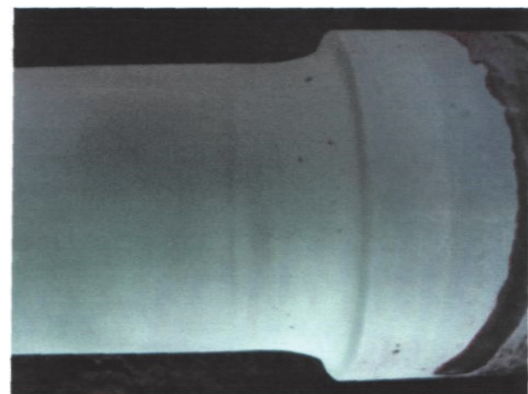
Figure 12: Pores in unbroken spindle junction areas

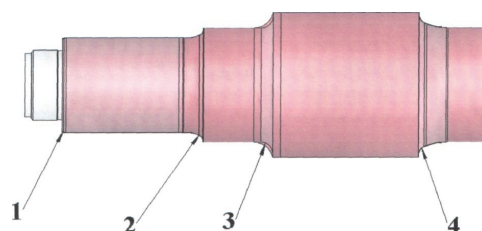
If the two axes are analyzed comparatively, the existence of four areas where differences appear in terms of dimensions can be seen (Fig. 15):

Figure 15: Areas with differences in size

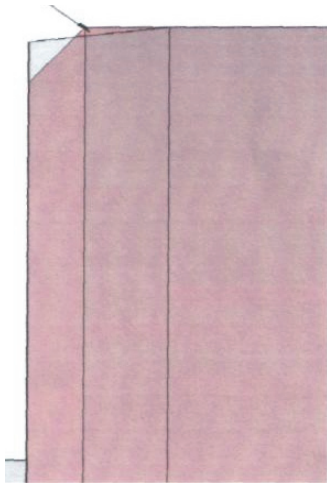
Figure 16: Zone 1

Zone 1 - The difference consists in the existence of an additional clearance on the A II axis (5 mm x 6°), which is only found on the A I and OR 1 axes (Fig. 16).

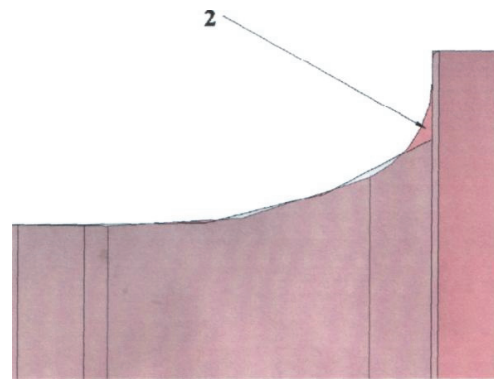
Figure 17: Zone 2

Zone 2 - The difference between the connection radii in the spindle - shutter connection area, which imposed the loading by welding the old axle (Fig. 17).

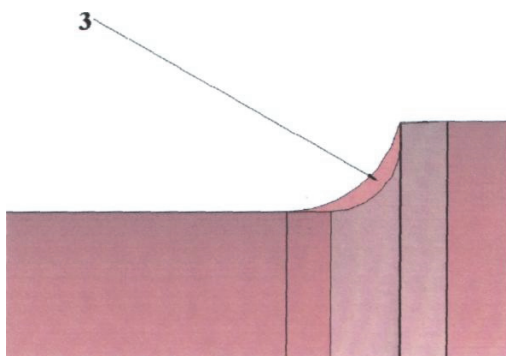
Figure 18: Zone 3

Zone 3 - The difference between the connection radii in the connection area of the mounted shutter, which imposed the loading by welding of the old axle (Fig. 18).

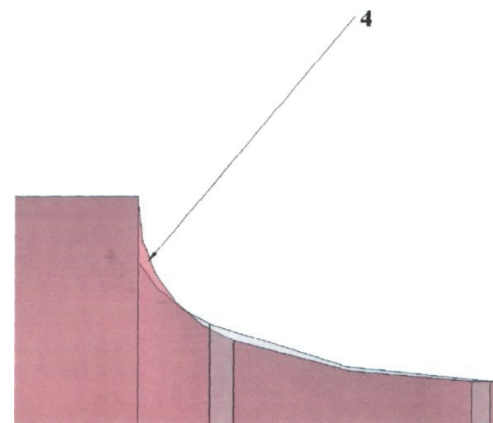
Fig. 19. Zone 4

Zone 4 - The difference between the connection radii in the center of the axle, which imposed the welding loading of the old axle (Fig. 19).

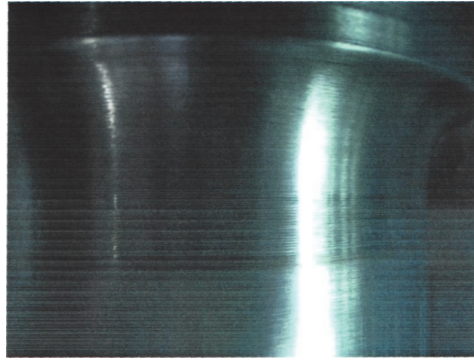
The roughness measurements in the connection areas indicated much higher roughness values than those provided in the documentation ($R_a = 5 \dots 5.5 \mu\text{m}$, compared to $R_a = 0.8 \mu\text{m}$ imposed by the drawing) (Fig. 20).

Figure 20: High roughness in the connection area

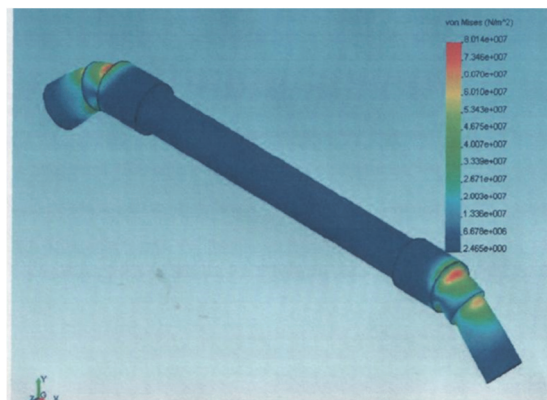
After the finite element discretization of the 3D CAD model of the type A II axle, the numerical calculations were performed and resulted in a maximum von Mises stress value of 80.14 MPa), which is well below the breaking limit of the material used for production of axles (Fig. 23), value between 550 and 700 MPa (according to the U.I.C. 820 sheet).

Figure 23: The von Mises stresses resulting from finite element calculations on the 3D CAD model of the type A II axis, in the case of static stresses

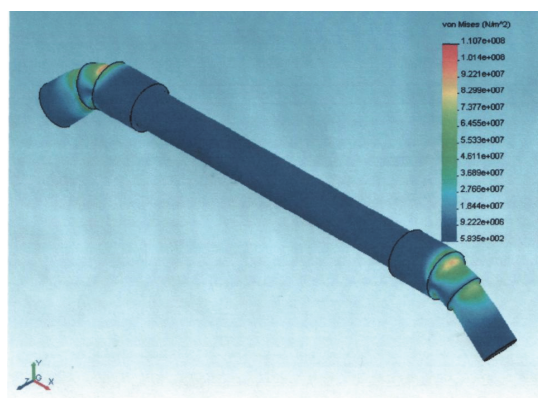
The maximum stress thus calculated, considering the dynamic stresses in curves, with the axle not braked, is 110.7 MPa (Fig. 24).

Figure 24: The von Mises stresses resulting from finite element calculations at the 3D CAD model of the axle type A II, in case of dynamic stresses
