An analysis regarding train derailments caused by cracked wheelsets

Eugen Ghita¹

¹Politehnica University, Faculty of Mechanical Engineering, Timisoara, Romania

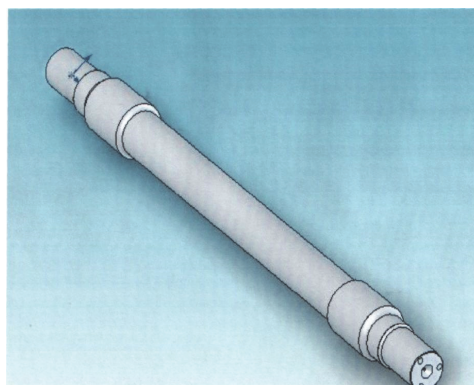
A 3D model of the AII axle was made using a mechanical design software (Solid Works). Constraints, static or dynamic loads were applied to this model (Fig. 21) in order to be able to determine the value of the von Mises stresses by numerical methods.

Figure 21: 3D CAD model of axle type A II

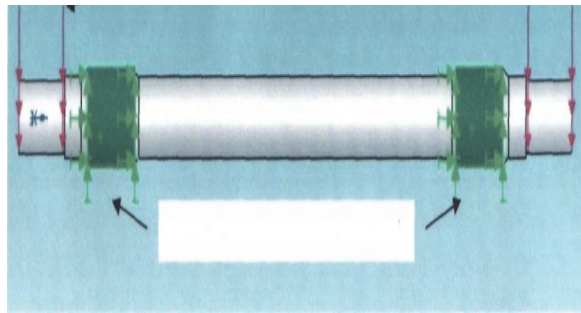
Also, a maximum load of 100000 N was applied to both ends of the axle (Fig. 22). Two estimates were made: an estimate of the stresses that appear in the axle in the case of applying the nominal static load and a second estimate of the stresses that appear in the axle as a result of dynamic stresses in curves, with the axle not braked.

Figure 22: Constraints and loads applied to the 3D CAD model of the type A II axis
